# COLMIX - Deep Soil Mixing in New Zealand – An update

**ABSTRACT:** This paper presents recent developments in the use of deep soil mixing technique in New Zealand road slip repair works. A brief overview of New Zealand road maintenance history is presented, and the current role that deep soil mixing is playing is described. Valuable experience has been gained through the design and construction of deep soil mixing road remedial works. Key issues include composite behaviour and group effects of deep soil mixing of columns, and identifying failure mechanisms. The benefits of deep soil mixing are illustrated through case studies.

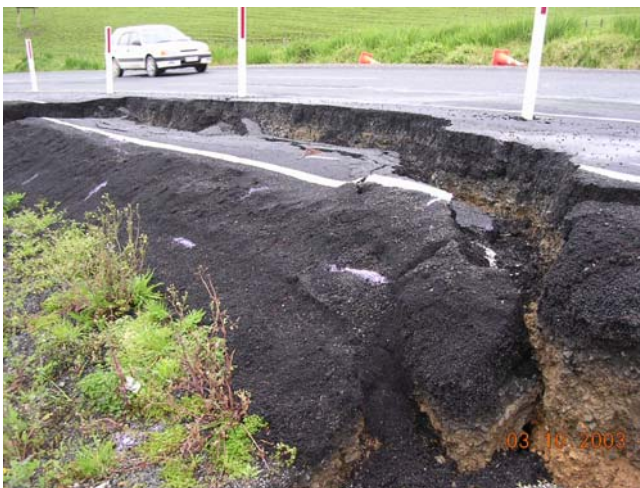
Figure 1: A recent New Zealand road underslip

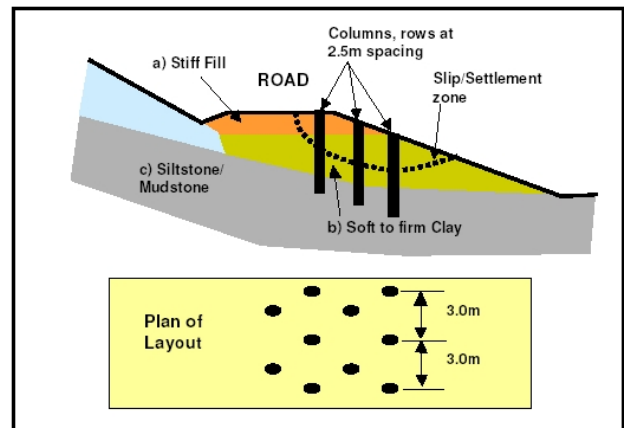
The subsurface conditions comprise 1.5 m thick embankment fill overlying 3.5 m of soft to firm clay and 1-1.5 m of stiff to very stiff clay. The stiff clay is probably weathered material derived from the underlying mudstone. The ground conditions and Colmix column layout adopted for the Edwards slips are shown in Figure 5.

Figure 5: Ground conditions and colmix layout at Edwards (Finlan et al., 2004)

The remedial works installed comprised 3 rows of columns over a 50 m road length. The columns were spaced at 3 m in the longitudinal direction, and the rows were spaced at 2.5 m centres. The columns were generally installed to a maximum of 6 m depth although early refusal was encountered in some places. The remedial works was designed assuming 1.5 MPa unconfined compressive strength (UCS) for the Colmix columns. The design factors of safety adopted were 1.5 for normal groundwater conditions, and 1.1 for the extreme groundwater conditions. The construction of the Colmix remedial works took 9 working days.

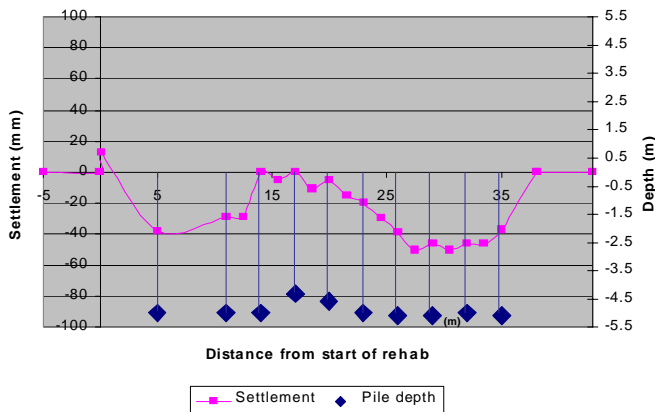
Road deformation has been monitored at the Edwards slips on a regular basis. The ongoing monitoring has shown some presence of pavement deformation that looks like a “telegraph wire”, that is, the deformation is characterised with small continuous undulation with localised depressions at several places. The maximum vertical displacement of 40-50 mm has been observed as shown in Figure 6. The relatively large displacements coincide with areas where columns were terminated short of the bedrock. Back analysis by finite element has indicated that the 3m spacing is too great. Subsequent designs have limited column and row spacings to no greater than 2.5m.

Figure 6: Post construction road deformation at Edwards

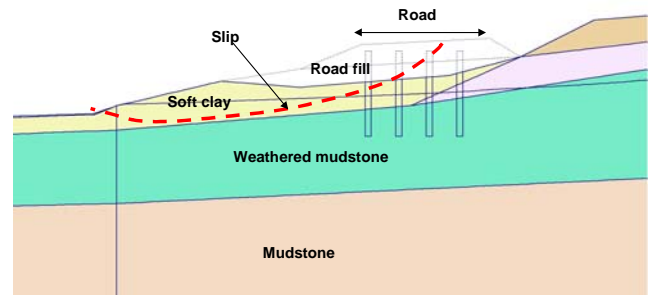
The slip site comprises a 1.5m deep embankment fill over 4.5m of soft to very soft clay layers. High groundwater levels occur at the Portland site as the site is in close proximity to a river subject to tidal actions. The ground conditions at Portland are shown in Figure 7.

Figure 7: Ground conditions at Portland

The Portland slip was repaired with 4 rows of Colmix columns over a 45 m road length. The columns were spaced at 2.5 m intervals, and staggered between adjacent rows. The four rows of columns were constructed at 2.5 m spacings. The Colmix columns were designed to be installed to a maximum depth of 7 m below ground level. The Portland remedial works was designed assuming 0.8 MPa UCS design strength. The design factors of safety adopted were 1.5 and 1.1 for the normal and extreme groundwater conditions, respectively. The remedial works were completed in 18 working days. It proved difficult to drill through the highly plastic clays, and predrilling was therefore required in some places.

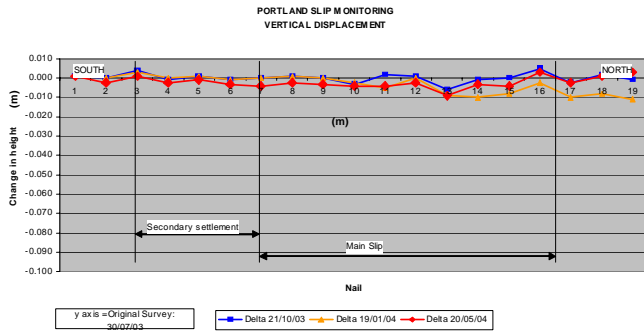
Nails were installed on the pavement following the completion of the Colmix columns. The movement of the nails was monitored in three surveys over eight months. Insignificant vertical and lateral movements were observed in the post construction surveys, as shown in Figure 8. Small settlement was observed immediately adjacent to the main slip area where the slip movement is visible.

Figure 8: Post construction road deformation at Portland

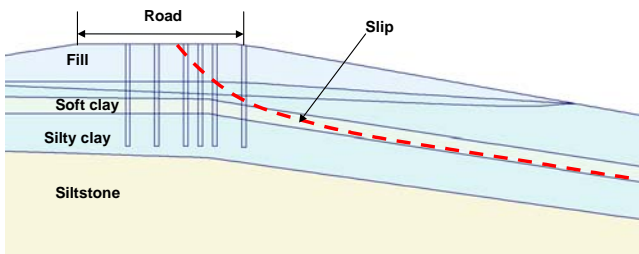
The ground conditions of the Mountain Road Crawler Lane slip comprise 2.5m embankment fill, 1.5m stiff to very stiff clayey silt, 2m very soft to soft silty clay, 1.5m stiff silty clay, overlying mudstone, see Figure 9.

Figure 9: Ground conditions at Mountain Road Crawler Lane slip

4 rows of Colmix columns were constructed at 2.0 m intervals over a 50 m road length. The row spacing was also 2.0 m. The columns were constructed to a depth of 7 m except where bedrock was shallower than expected. The Colmix columns were constructed in 7 working days.

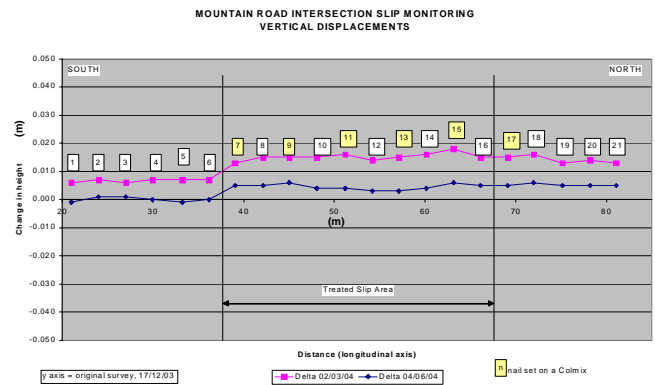
Figure 10 shows the post construction road deformation measured at Mountain Road Crawler Lane. The observed deformation is generally within 10 mm, and could be partly attributable to survey accuracy.

The uniform nature of the observed deformation pattern is suggestive of shrink swell movement of the soil. This type of materials are likely to have undergone significant strain, and residual shear strength parameters may be more appropriate for design purposes. The design should also allow for shrink swell movement.

Figure 10: Post construction road deformation at Mountain Road Crawler Lane slip
