Ten Walls in Ten Weeks

Case studies in the use of Launched Soil Nail Supported GCS walls in the Far North District

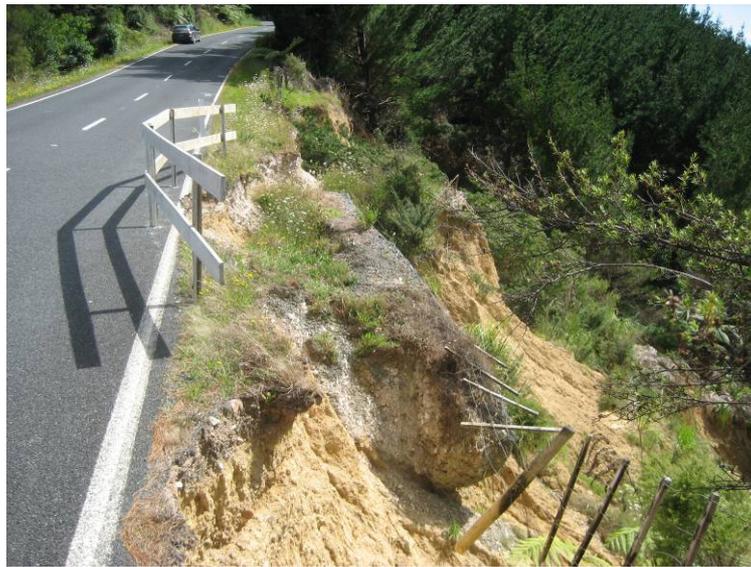
Figure1: Typical Slope failure after storm event

A rapid response with urgent remedial measures was needed to re-open the roading network. Following the storm event geological and geotechnical inspections were carried out along all

roadways within the Far North District and over 60 significant slope failures along the roading network identified.

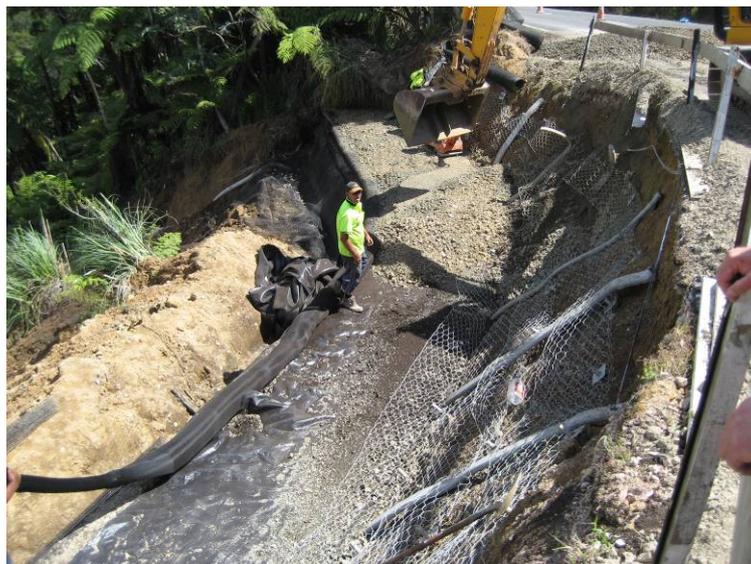
This reduction provided a considerable cost saving to the client and allowed for faster construction as the proposed scheme would benefit from a significantly reduced quantity of granular backfill to construct the walls. By providing a structural connection between the LSNs and the GCS wall, the effective overall width of the “reinforced soil block” was effectively increased and both elements would act compositely. A photo of this typical arrangement is shown in Figure 3 below.

Figure 3: Construction stage showing connection between LSNs and GCS backfill

A key part of the design philosophy was to use launched soil nails (LSN's) to control the lateral earth forces upon the back of the proposed GCS walls. This allowed the width to height ratio of the walls to be greatly reduced to as low as 0.3. Typically in MSE and GRS walls this figure is between 0.6 and 0.7.

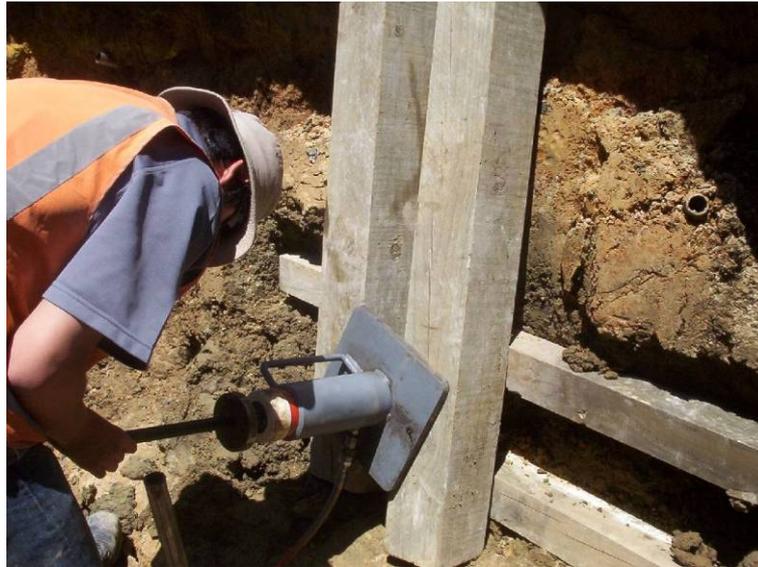
For the final verification step a pull-out test on the nail was simulated in the model. The result of this was then correlated against an in-situ shear strain verification test on the nail. The correlation allowed for verification of design assumptions, in particular the interface factor.

Figure 6: In-situ shear strain verification test

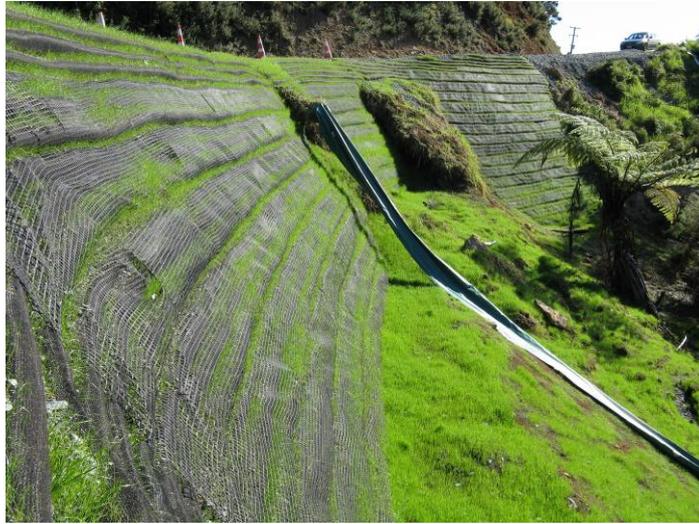
Figure 8: Photo of completed Wall

By utilising the additional benefits of LSN's with GCS walls, the failures were able to be remediated in record time and have proven to be excellent value. The client is satisfied that, compared to the cost of a conventional tie-back walls, the LSN/GCS combination cost significantly less and were able to be constructed in one-quarter of the time. Other key benefits of the LSN/GCS walls are:
