Innovation in Slip and Settlement Remedials: the Soil Mixing Option

This paper examines the soil mixing technique, its applicability to slope instability remedial works and outlines the design and construction process including a number of case studies.

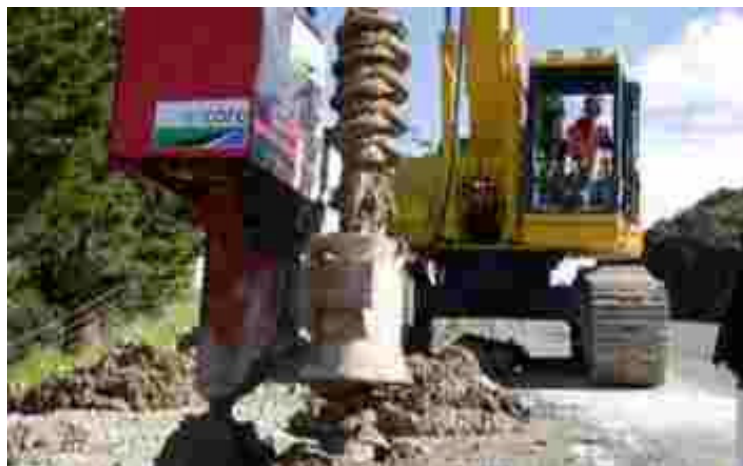
Figure 2. Close-up of the counter-rotating auger head assembly

The process is performed by using twin counter rotating augers with opposite pitches. The twin augers are located at the end of drill rods and each features a disaggregating drill head with grout outlet port. The result of the twin auger mixing is interlocked helixes over the full length of soil mixing.

Construction begun in March 2003 and 60 columns were installed in 10 working days using the twin counter-rotating auger as shown in Figure 2.

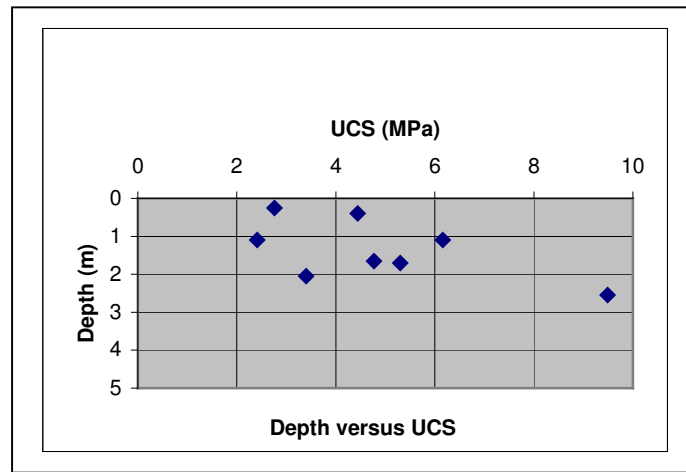
Figure 3. Unconfined Compressive Strength Test Results

Complete construction records for each pile, including depth, rate of penetration and material quantities are maintained, together with a layout plan of the columns. To monitor construction quality, selected columns were cored after 80 days to provide samples for UCS testing.

The resulting unconfined compression strengths of the tested core samples are shown in Figure 3 below. The test results are compared to the design values to ensure design requirements have been met.

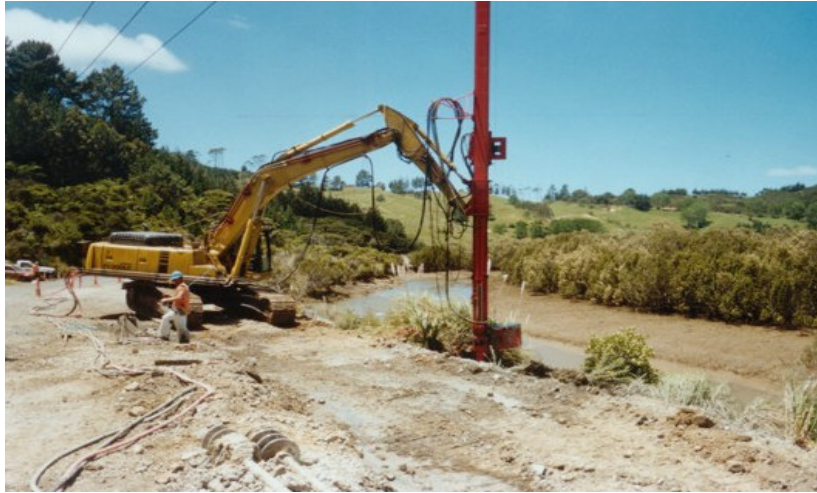
Figure 5. Installation of columns

Construction begun in December 2002 and 82 columns were installed in 12 working days. Since installation there has been no signs of instability and/or settlement after 7 months (to July 2003).
