# COLMIX - Deep Soil Mixing in New Zealand – An update

**ABSTRACT:** This paper presents recent developments in the use of deep soil mixing technique in New Zealand road slip repair works. A brief overview of New Zealand road maintenance history is presented, and the current role that deep soil mixing is playing is described. Valuable experience has been gained through the design and construction of deep soil mixing road remedial works. Key issues include composite behaviour and group effects of deep soil mixing of columns, and identifying failure mechanisms. The benefits of deep soil mixing are illustrated through case studies.

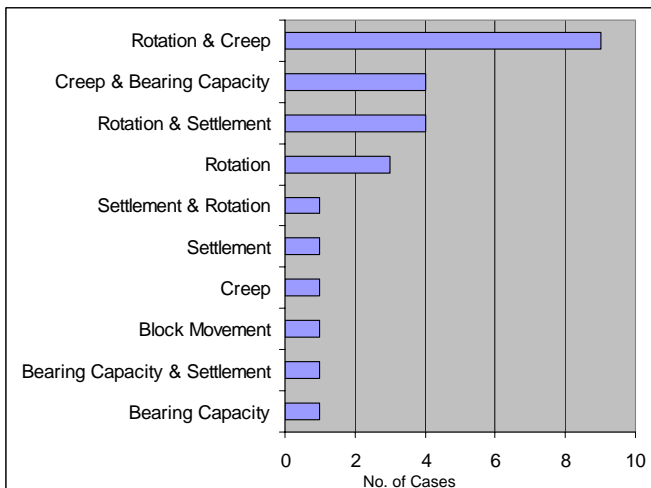
Figure 4: Types of failure mechanisms repaired to date

Because of the above characteristics of the Northland Allochthon, several slip mechanisms are observed in Northland, including rotational and translational slips, settlement, bearing capacity failure and creep. Slips often

result from a combination of multiple mechanisms. Therefore sound assessment of the slip mechanisms is important as appropriate remedial measures cannot be implemented without identifying all of the mechanisms taking place. Figure 4 summarises the primary and secondary mechanisms of the road slips that have been repaired using Colmix remedial solutions. Primary mechanisms are mentioned first, followed by secondary mechanisms.
